Former School Building
Alliston, Ontario

“A project specific designated substances survey was conducted to identify designated materials for abatement prior to building demolition.”

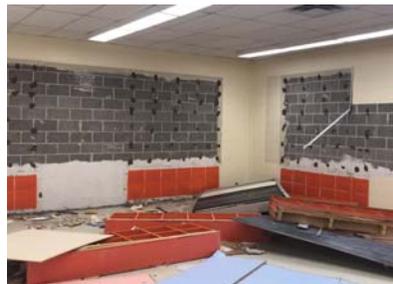
Fig. 1—Mastic (asbestos containing material) behind chalk boards

Peritus staff worked with the client and the contractor to develop an abatement plan including Type 3 abatement for plaster wall, Type 1 abatement for mastic and glove-bag operation for pipe wrap removal. Peritus staff completed multiple site inspections during the abatement process. Inspections were conducted prior to and during abatement to confirm enclosure setup and use of appropriate disposal containers. Final inspections were conducted to verify that the asbestos and lead containing materials were removed and disposed at an appropriate hazardous waste facility.

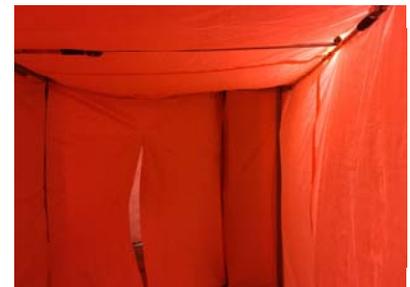
Fig. 2—Type 3 abatement enclosure
