Existing Building
Constructed in 1952
Toronto, Ontario

**“The
designated
substances
survey was
used to identify
sources of
asbestos and
lead for
abatement and
demolition
purposes.”**

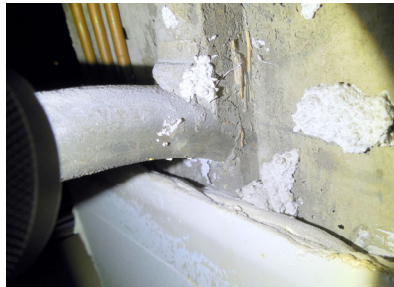
Fig. 1—Asbestos was found in the pipe wrap

The building was fully inspected using intrusive techniques. An initial visual inspection of all floors of the building was conducted followed by destructive testing. Samples were collected and analyzed for asbestos and lead. Visual observations and analytical data were summarized in a DSS report and quantified the amount of asbestos and lead in the building. The report was used by contractors for the abatement process.

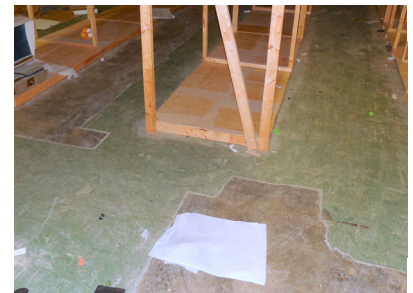
Fig. 2—Floor tile containing asbestos
